No. 1465523.7

SAMPLE DESCRIPTION:
Luxury Vinyl flooring planks – Code 456123 GH LVP
01219X184 fixed to a clear Perspex base using:
- Rapid set smoothing compound and absorbent mat
used to prepare Perspex to receive the planks.
- Adhesive Polyurethane 1 part.

ISO 4760:2022(E) - LAMINATE FLOORING – TOPICAL MOISTURE RESISTANCE – ASSEMBLED JOINT (MODIFIED)

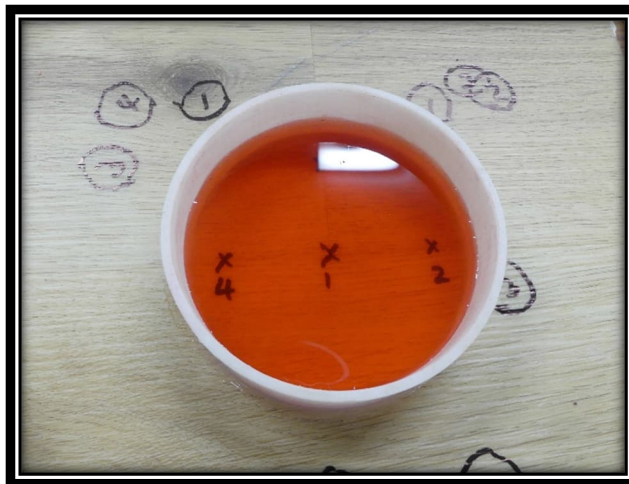
After 24 hrs With Water

100 mls of dye solution was applied onto the sample surface. It was poured into a cylinder 100mm diameter placed in the centre of the sample at the “T joint.” Sealant was used at the plank/cylinder interface to avoid leakage.

The underside of the sample was inspected through the clear Perspex to enable detection of any dye penetration through the sample.

The sample was left at 20°C, 65% Relative Humidity room conditions for 24 hours after the dye was added and then examined for dye penetration through the backing (not 23°C, 50% RH as stated in the method).
